SERVICE BULLETIN

Bulletin #74

57448 Case Main Cap Cracking

June 5, 2000

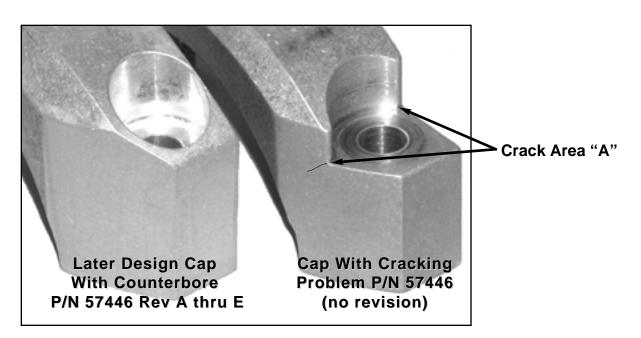
with the caps in question were manufactured up to March 1997. Caps with the improved design are part number 57446 with an A thru E revision. These caps were not stamped with part numbers until June of 2000. Comparing to the photo contained in this bulletin will identify the caps in question.

We have had instances of cracks developing in the corner where the main nut and washer grips the cap. We recommend inspection of this area on a regular basis to detect the start of any cracks and to prevent a catastrophic failure. These cracks have occurred on Aluminum Thru Bolt Cases with the 3.812" bore only, part number 57448.

Before running check area "A" for any cracks developing in the milled corner. It may be necessary to use a magnifying glass to detect the cracks. We also recommend using a die penetrate inspection to detect cracks not visible to the eye. Dye penetrate inspection kits are available from Mark Williams, part number 406. This inspection should be repeated after every 5-10 runs for cars that are included in the SEVERE DUTY CATEGORY.

Any cap that shows signs of cracking should be retired from service. There is no satisfactory repair procedure to the existing cap that will correct this problem. The case should be replaced with one that has the later style caps. The individual caps cannot be replaced as they are align bored as an assembly.
